Weston under Penyard – Programmes of Work for Lengthsman and Prow Maintenance

APPENDIX – Maintenance Plan proposed and approved by the Parish Council on 7th November 2016.

Proposed Maintenance Plan for Public Rights of Way (PROW)

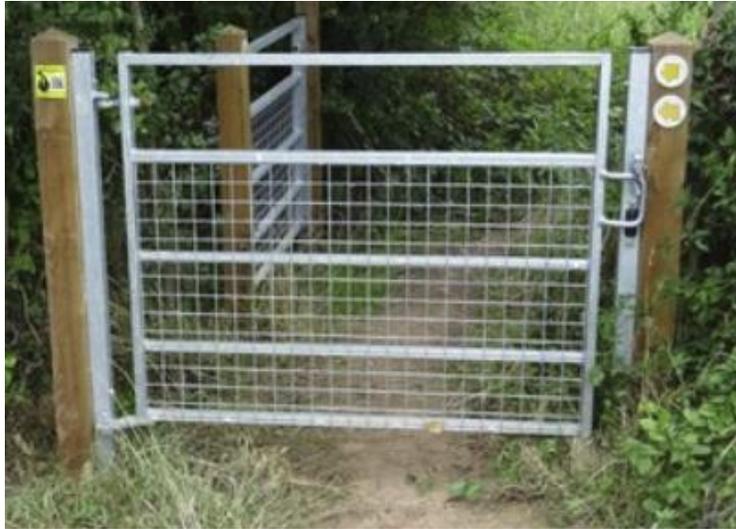
Steel Self Closing Gate

The total number of new gates for the above three routes is approximately 26, with a purchase cost of about £5,5012 (at the 2016 unit-rate of £212 per kit). New gates should always be steel (with 25 years guarantee). They must be gravity self-closing with a latch, to ensure that they cannot be left in the open position, as long as they are installed correctly. The more expensive and less accessible kissing gates should not normally be required.
